# EPA Region IX and California Water Resources Control Board

## NPDES Compliance Evaluation Inspection (CEI) Report

<b>Name and Location of Facility Inspected</b> City of Eureka - Elk River Wastewater Treatment Facility 4301 Hilfkier Lane Eureka, CA 95503		<b>Entry Date</b> 3/15/2013  <b>Entry Time</b> 8:00 AM	<b>Permit Effective Date</b> 7/24/2009
<b>NPDES Permit Number</b> CA0024449	<b>Order Number</b> R1-2009-0033	<input checked="" type="checkbox"/> <b>Major</b>  <input type="checkbox"/> <b>Minor</b>	<b>County</b> Humboldt County  <b>Permit Expiration Date</b> 7/24/2014
<b>Name(s) &amp; Title(s) of On-Site Representative(s)</b> Bruce Gehrke (Utility Operations Manager)	<b>Contact Information</b> Phone: (707) 441-4360 Fax: (707) 441-4366 E-mail: bgehrke@ci.eureka.ca.gov	<b>Notified of Inspection?</b> <input checked="" type="checkbox"/> <b>Yes</b> <input type="checkbox"/> <b>No</b>	
<b>Name, Title &amp; Address of Responsible Official</b> Bruce Young (Public Works Director) 531 K Street Eureka, CA 95501	<b>Contact Information</b> Phone: (707) 441-4203 Fax: (707) 441-4202 E-mail: byoung@ci.eureka.ca.gov	<b>Official Contacted?</b> <input type="checkbox"/> <b>Yes</b> <input checked

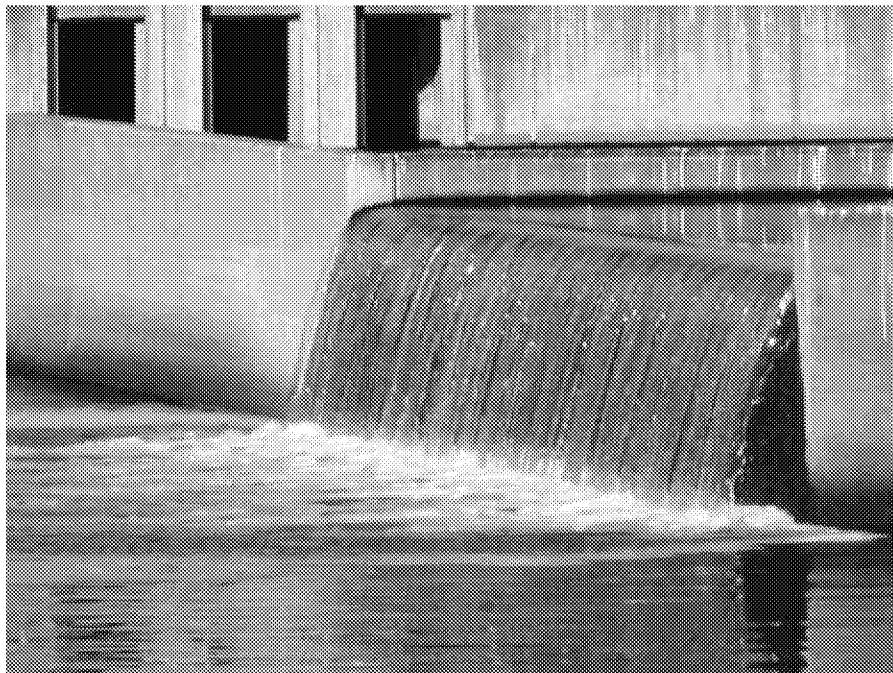
Photo 2: Effluent viewed discharging from the chlorine contact tank to the effluent holding pond.

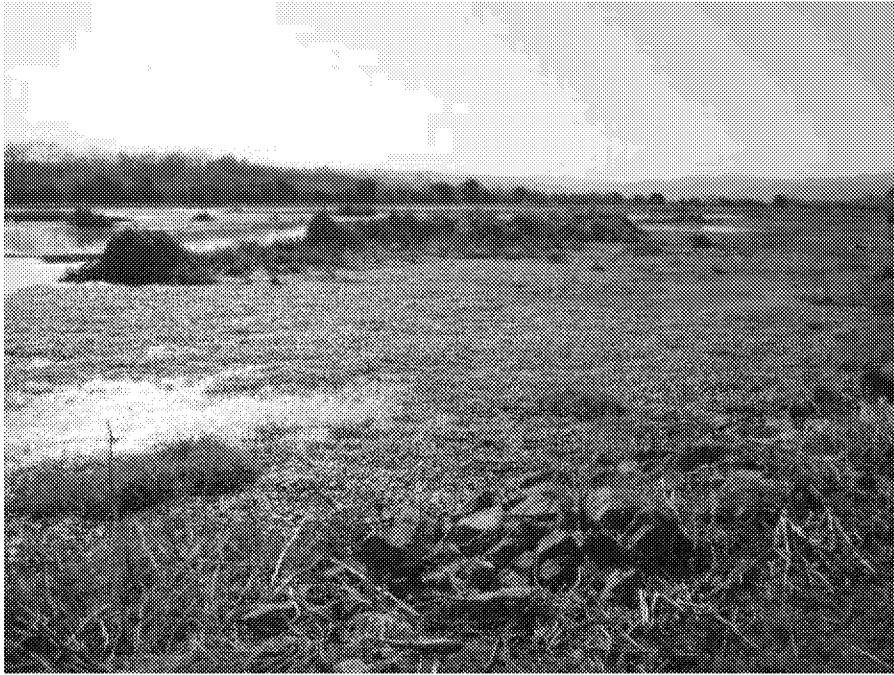
INSPECTED ITEM	EVAL
1. Biosolids/solid waste disposal/reuse method(s) (e.g., land application, landfill, etc.): <i>Grit and screenings are hauled to a local landfill and biosolids are processed onsite. The Facility does not have a permanent solids handling method. The primary on-site Facility representative stated that Synagro, a contract biosolids company, brings temporary processing equipment to the site to process solids prior to disposal. The Discharger is studying alternative methods for processing solids at the Facility. One of two solids holding ponds is nearly full (refer to Photo 3).</i>	M

Photo 3: One of two sludge holding ponds which was observed to be nearly full at the time of inspection.

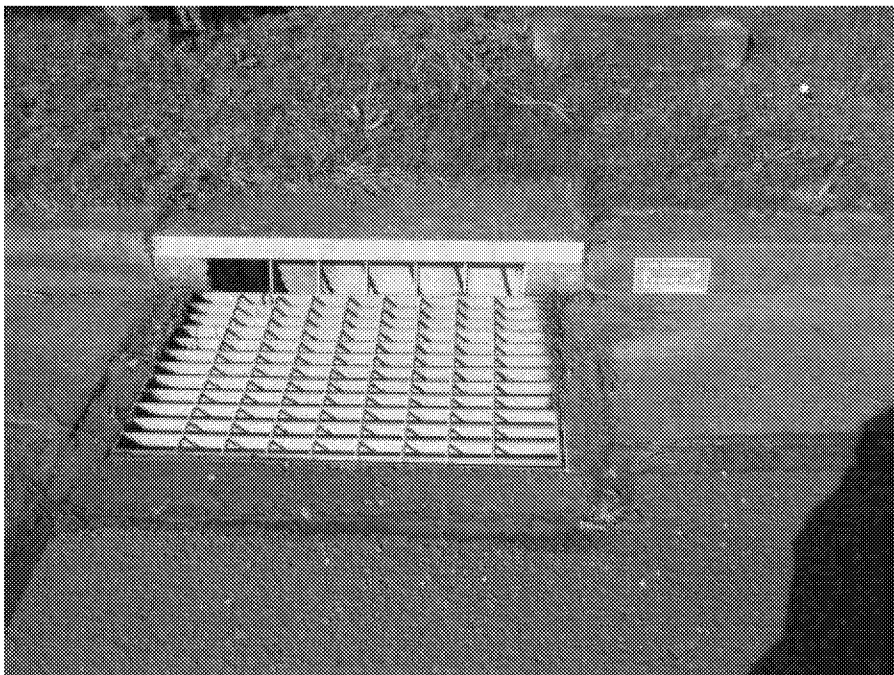
1. North Coast Water Board Order No. R1-2009-0033, Provision VI.C.6.a requires that “For the control of stormwater discharged from the site of the wastewater treatment plant, if applicable, the Discharger shall obtain authorization to discharge under and meet the requirements of the State Water Board’s Water Quality Order 97-03-DWQ, NPDES General Permit No. CAS000001, Waste Discharge Requirements for Discharges of Storm Water Associated with Industrial Activities Excluding Construction Activities (or subsequent renewed versions of the General Permit).” The Discharger discharges stormwater from the Facility at several locations to an offsite swale west of the Facility, which discharges to the adjacent Humboldt Bay. According to the primary on-site Facility representative, the Facility does not have coverage under the General Permit. During the inspection, he contacted the City of Eureka stormwater coordinator who stated that stormwater was managed under the City’s MS4 stormwater permit. He further stated that he would acquire coverage under the general permit if the Facility was required to do so. The Facility does have a Storm Water Management Plan (SWMP) which appeared to be implemented.

Photo 4: One of multiple storm drains which discharge to an off-site drainage area. This storm drain is located on the west side of the loop access road west of the secondary clarifiers.
